INVENTORY SHEET FOR GROUP NOMINATIONS: IDAHO STATE HISTORICAL SOCIETY, BOISE, IDAHO

NOMINATION: (Lava Rock Structures in South Central Idaho)

SITE NAME: Allton Building

Lava Rock Structures in South Central Idaho
Allton Building, site 8

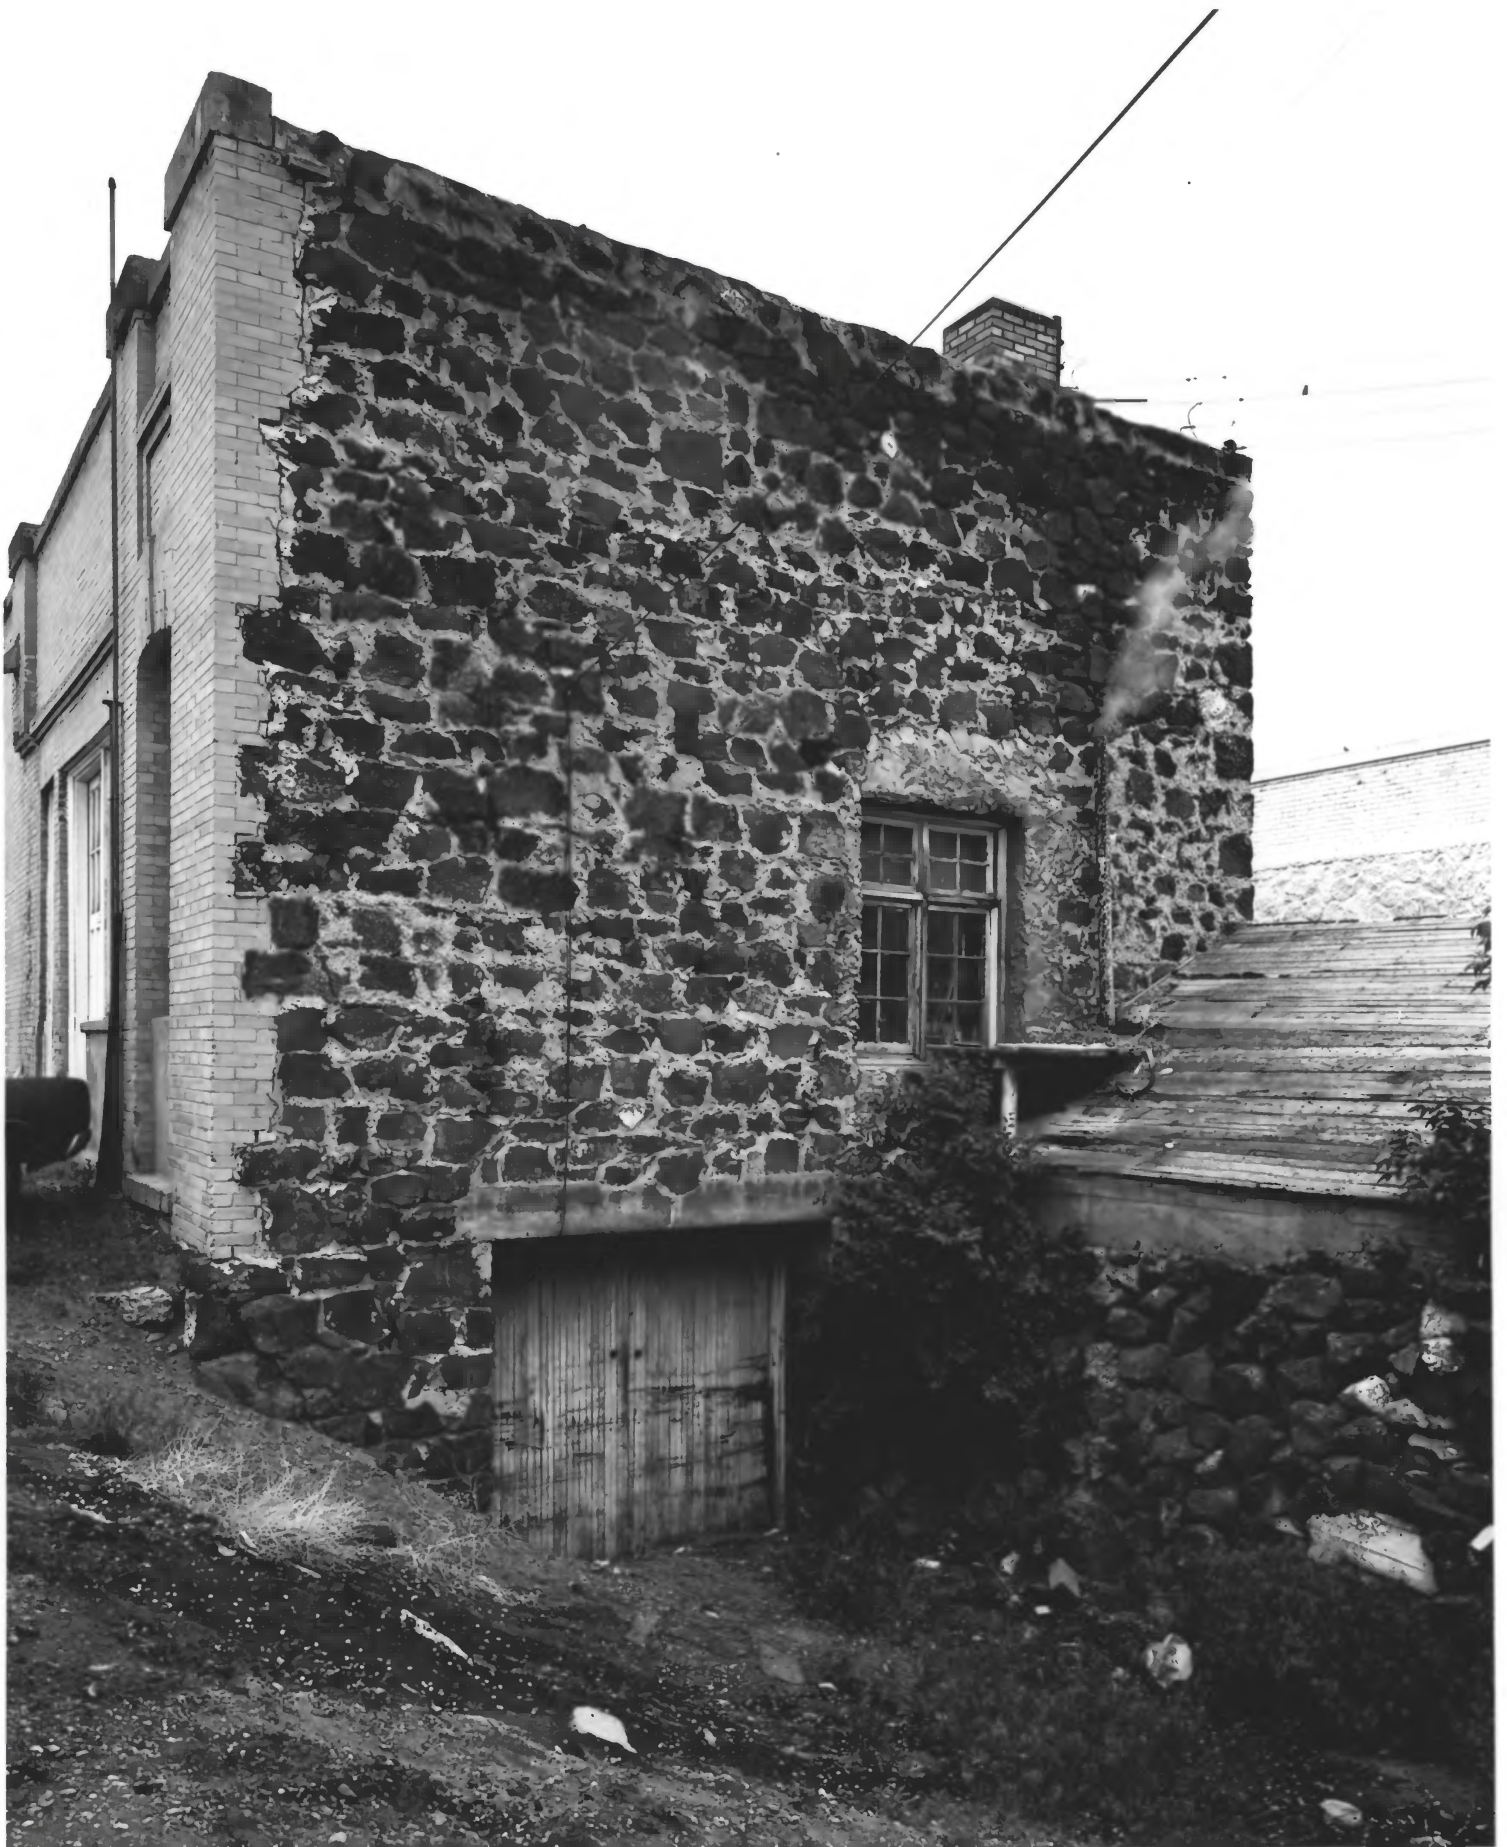
Photograph 2 of 2

View from northeast

This one-story, flat-roofed, rectangular building facing south onto Main Street is 25 feet wide and 60 feet long. The west wall and the back [north] wall are exposed lava masonry. The coursed rubble stonework has light tan untooled mortar in its wide flush joints. The west wall has been painted white. There is a full basement with stone walls three feet thick. The front and east sides have a white pressed brick veneer. There is an unpaved graded entrance to the basement offset to the left on the north exposure. This entrance has an approximately twelve-inch wide concrete lintel above a hinged double door of narrow, vertical, grooved wood. A small, one-story, shed-roofed frame structure on a dry stone base angles up from the side of the grade at the right of the basement door. The brick walls are American stretcher bond with tight joints with flush rose-colored mortar. Decorative black and white ceramic tile, a later addition, surrounds the display window on the south and covers the column supporting the corner to the top of the windows and door. The bricks are outset to resemble columns on the south and east sides of the building. Each of these simulated columns has a concrete coping about twelve inches wide. The top of the walls of the brick portion between the columns has a concrete coping about six inches wide. Offset to the right on the east exposure is a door with a transom. Above it is a flat arch two headers wide. To its right is a wide opening with a similar flat arch above it. The original opening was probably

for a warehouse door, but now there is a folding wooden door and a casement window with an eight-paned transom. Offset to the extreme right on this wall is a window with a segmental relieving arch two headers wide with an outset keystone above it. This window opening is closed with plywood. There are some alterations with concrete at the bottom of the last two windows. All windows in both the brick and stone walls are casement with six panes below and a transom with four panes above.
